# GEOLOGICAL CONTROL AND MITIGATION OF MALINO- MANIPI LANDSLIDE, SOUTH SULAWESI INDONESIA

Road access of Malino – Manipi is a main road from Gowa Regency to Sinjai Regency, South Sulawesi. In 4 years latter the road experiences landslide, which has an impact such as the road itself, furthermore economic activities of community in that area.

# 'GALODO' PADANG 2012: CAUSES AND PREVENTION

The Galodo Padang 2012 that has taken the lives is caused landslide in catchment area of Batang Kuranji river. The land slide it self is triggered by the heavy rain in few hours before. The slope of Batang Kuranji river catchment area is located in hilly terrain. The physical changes of the soil caused the loss of slope stability. To determine the cause of the Padang landslide 2012, the field investigation was conducted. The physical and mechanical properties of the soil in the area are examined. The research of physical properties is especially useful for understanding the behaviour of soil in the change of water content. The type of soil that dominates the catchments area is fine grained soil. This type of soil will change the mechanical behaviour with the change of the water content. Protection

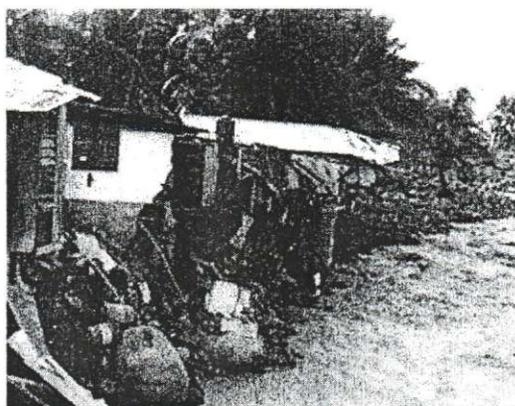
**Figure 1.** Scouring on the the river bang of Batang Kuranji due galodo I
